PORSCHE 911 COUPE

Full Pre-Purchase Inspection Report

VIN	**WP0ZZZ99ZHS110834**
First Reg.	**—**
Mileage	**45 949 km**
Engine/Fuel	**3.0**
Transmission	**automatic · dual-clutch (PDK)**

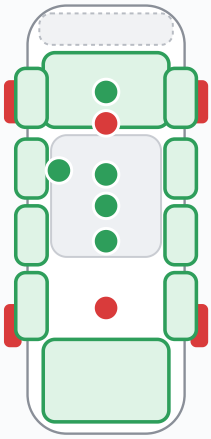
NEEDS ATTENTION

Brake · Front Left	35 %
Brake · Front Right	35 %
Brake · Rear Left	30 %
Brake · Rear Right	30 %

FINDING	RECOMMENDED WORK	COST
● **Brake · Front Left + Right**	Brake pads and discs replacement (per axle)	**350–800 €**
● **Brake · Rear Left + Right**	Brake pads and discs replacement (per axle)	**350–800 €**
Estimated total		**700–1 600 €**
